**Docket No. 217 – Development and Management Plan Inspection**

Northeast Utilities Service Company Certificate of Environmental Compatibility and Public Need for the construction of a 345-kV electric transmission line and reconstruction of an existing 115-kV electric transmission line between Connecticut Light and Power Company's Plumtree Substation in Bethel, through the towns of Redding, Weston, and Wilton, and to the Norwalk Substation in Norwalk, Connecticut.

**Date:** February 16, 2005

**Location:** Norwalk Substation Expansion

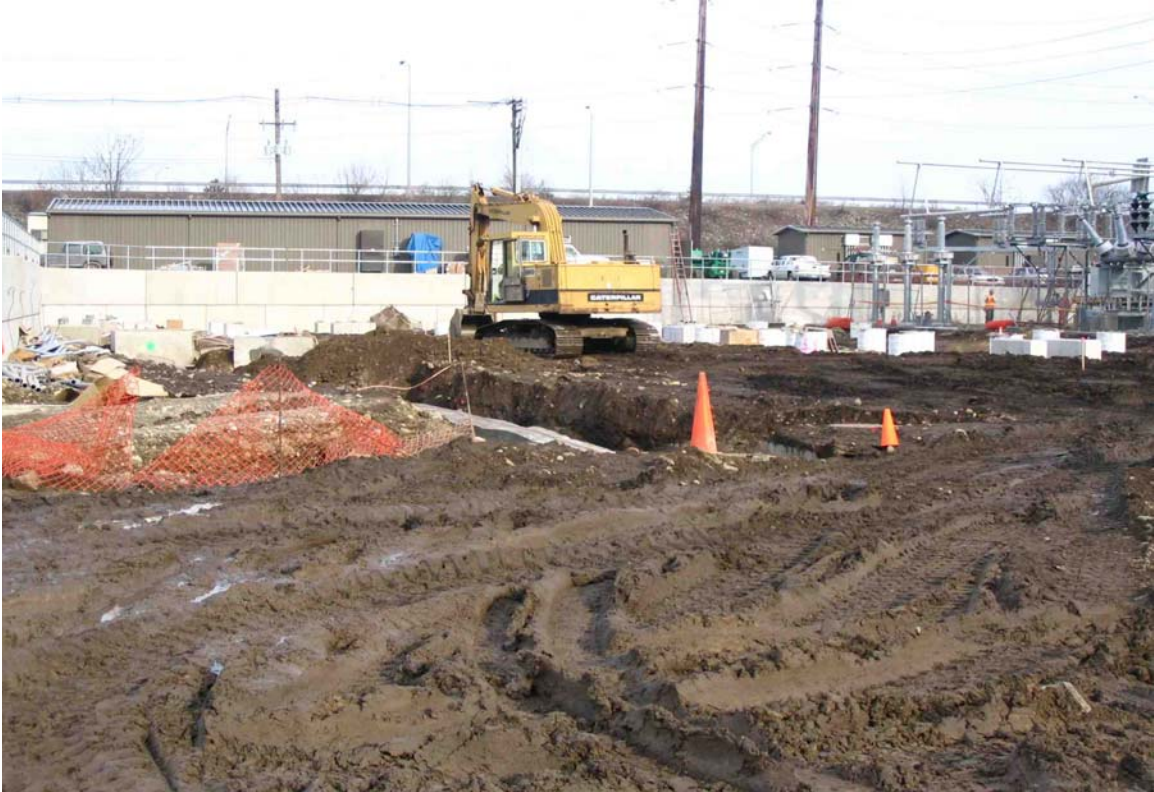
View of the continued excavation and backfill near wall #3. All soil remains well within the site.  
Photo from 2/9/05

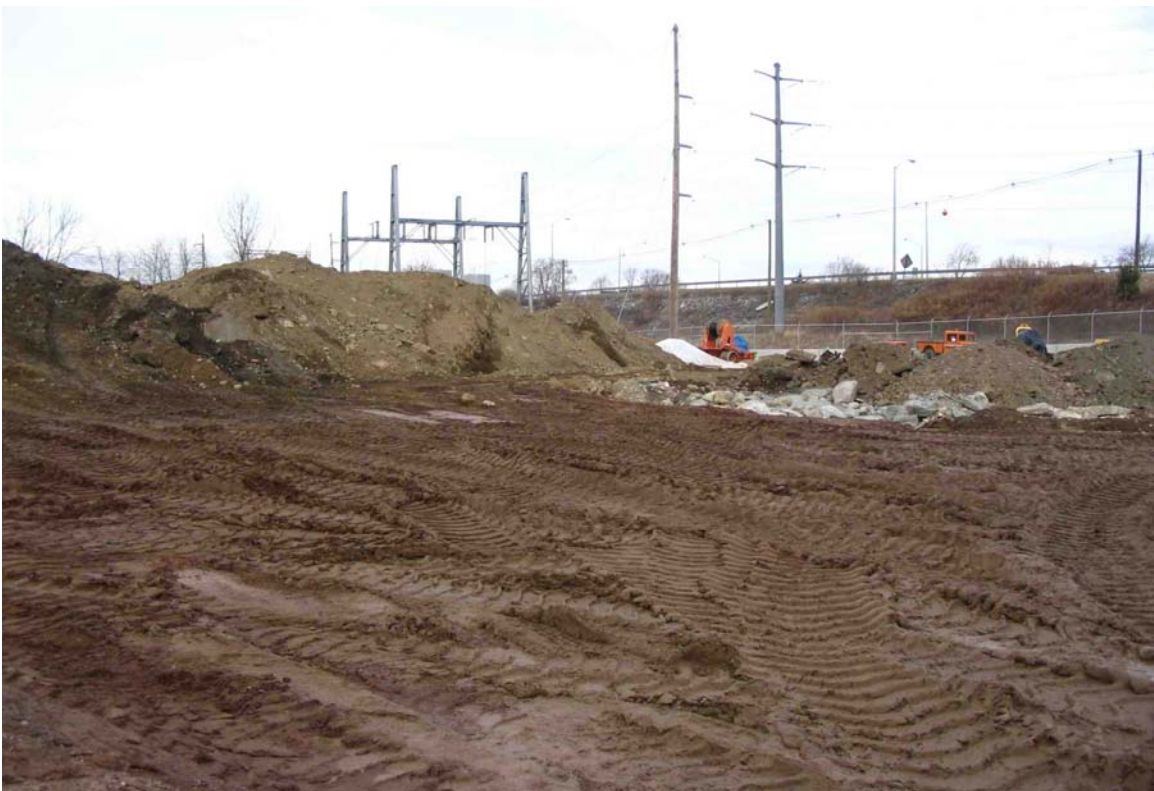
View of soil stockpiles up by retaining wall 2. Photo from 2/9/05

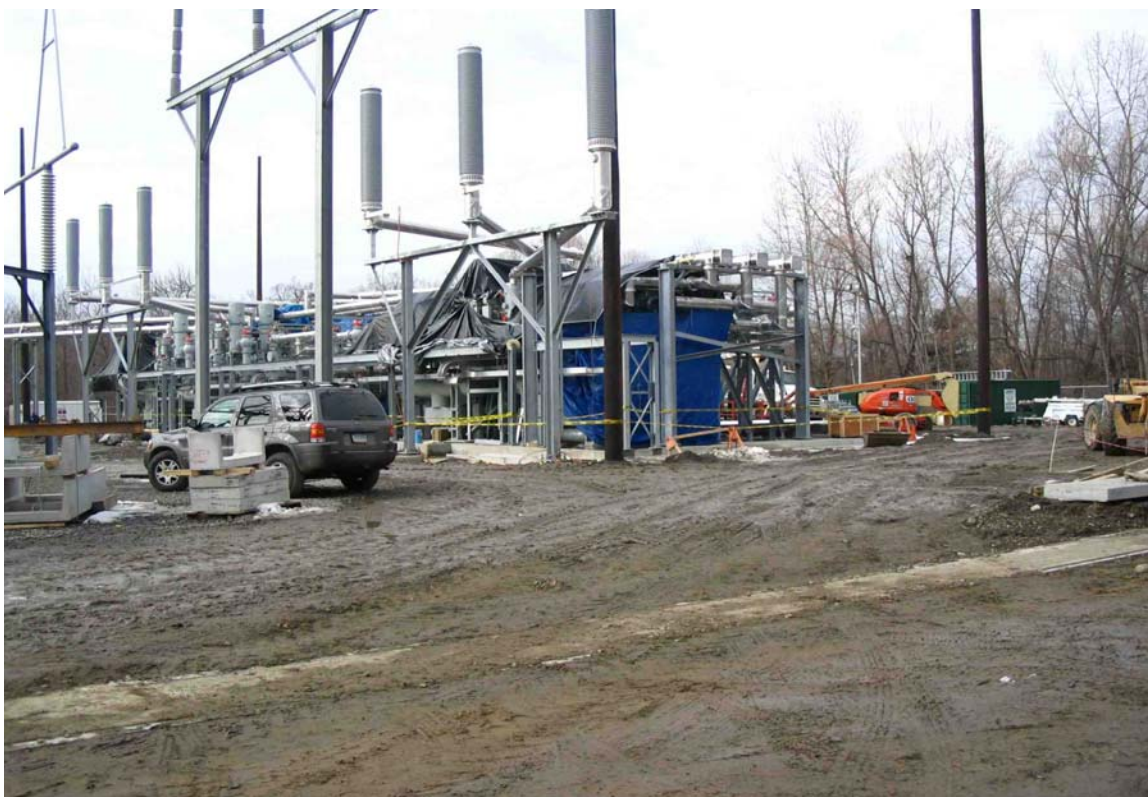
Plumtree Substation: View of completed cable trench in foreground. The majority of the work now involves excavation near the concrete slab. Photo from 2/9/05

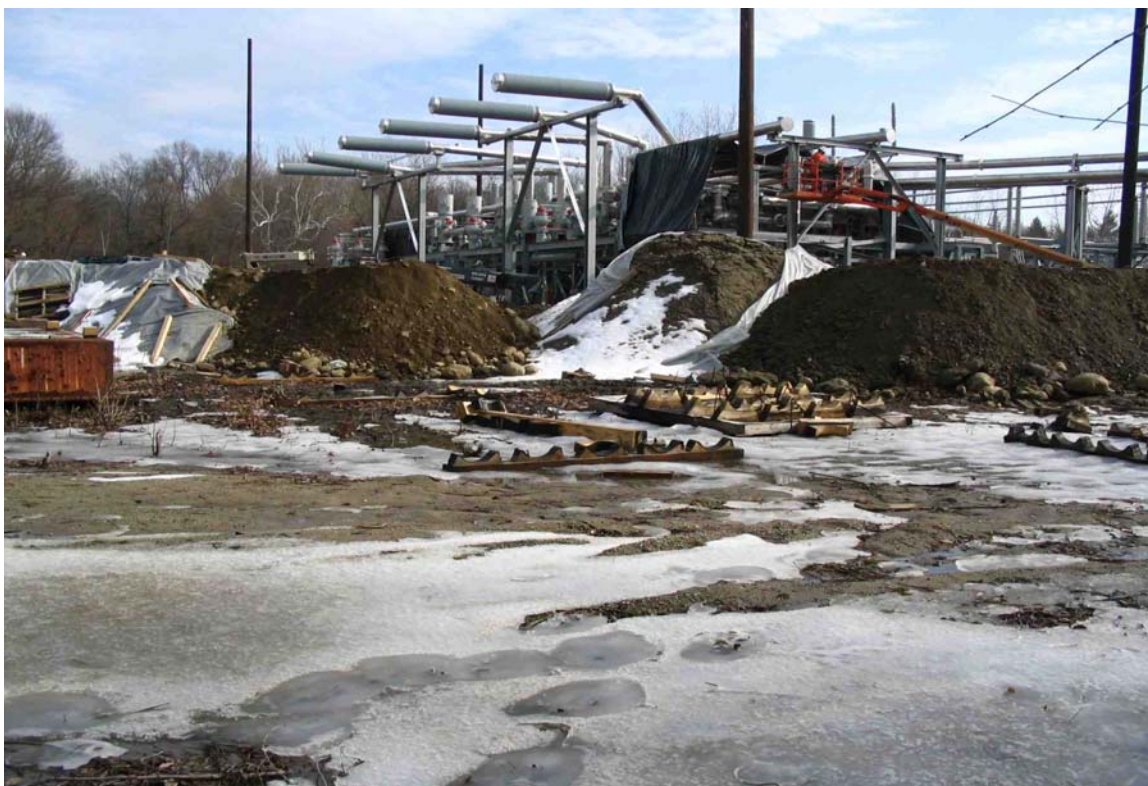
Stockpiles as they appeared on 2/9/05 have now been removed from the site for the most part with some minor backfill piles remaining.
